# North Dakota State Water Commission

RE: Inspection of McVile Dam

### INSPECTION OF MCVILLE DAM JUNE 3, 2013

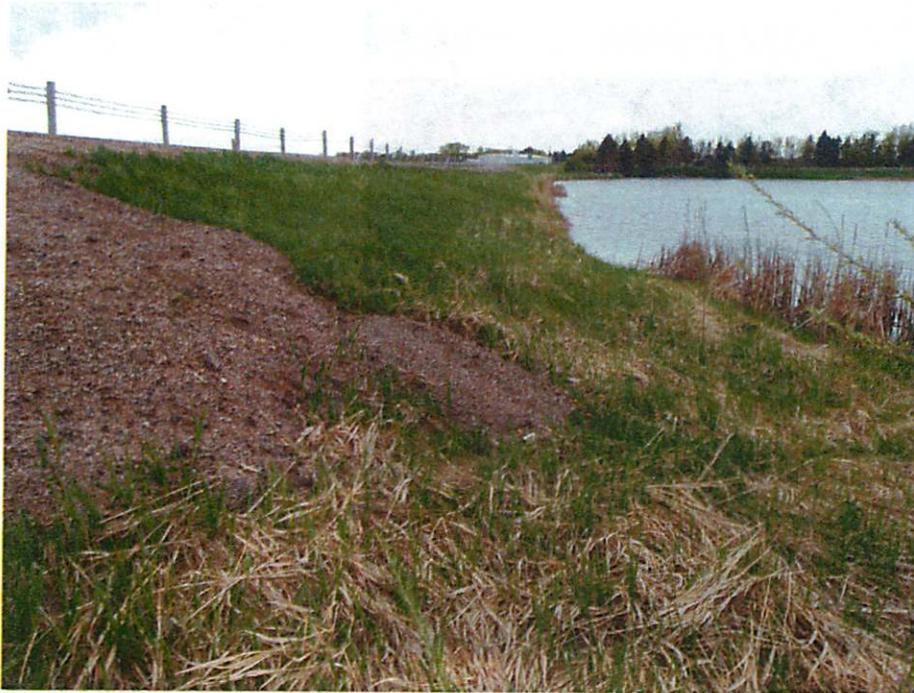
Photo #1 – Upstream slope, looking west.

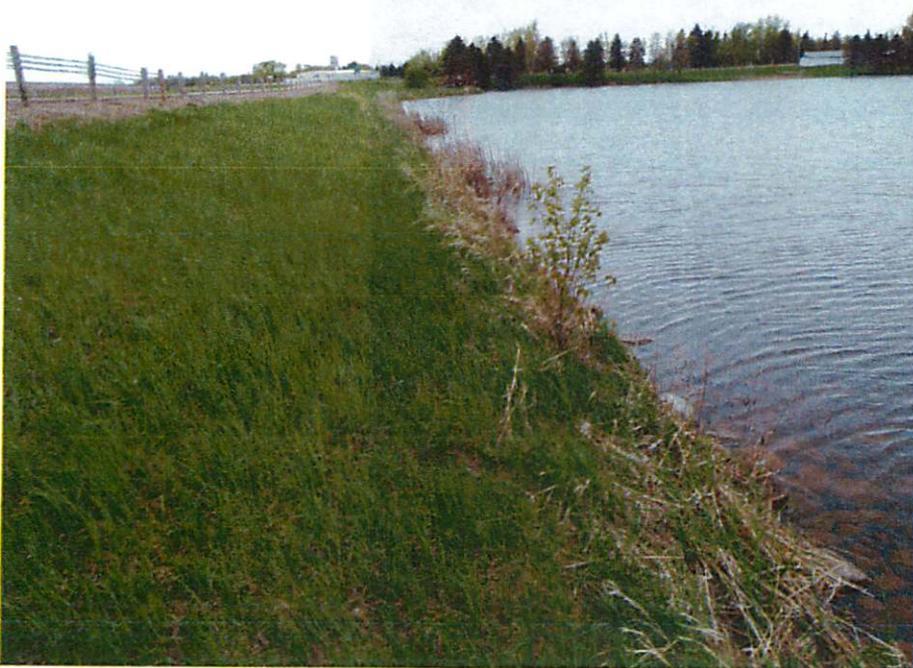
Photo #2 – Small trees growing on upstream slope.

- 1) Remove the small trees growing on the upstream slope and the bushes growing adjacent to the east wall of the stilling basin.
- 2) Attempt to control gopher activity on the dam embankment. Many gopher holes were found on the upper portion of the downstream slope near the east end of the embankment, as well as some at the west end of the upstream slope.

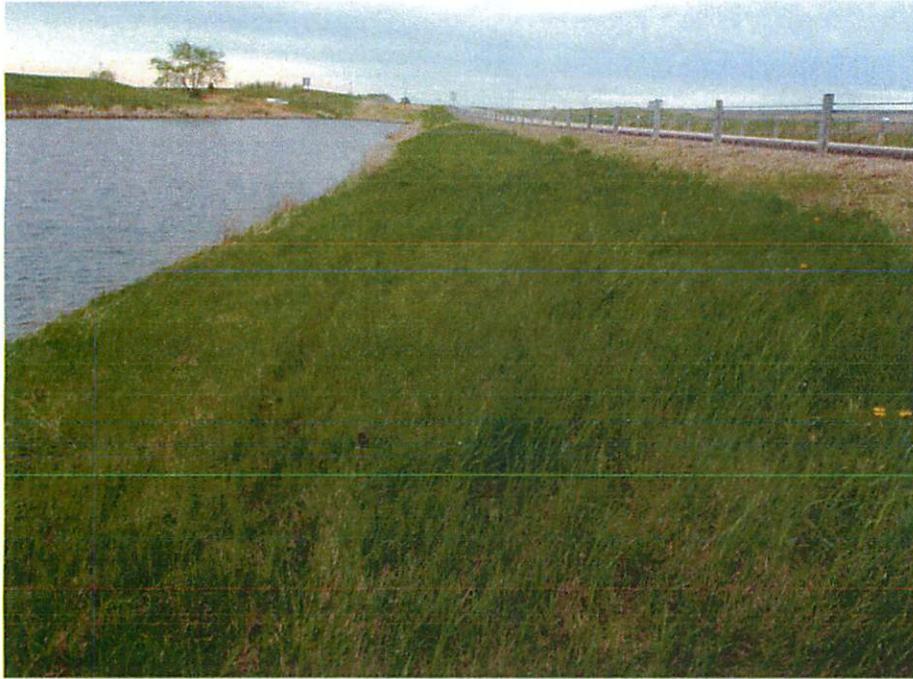
Photo #3 – Upstream slope, looking east.

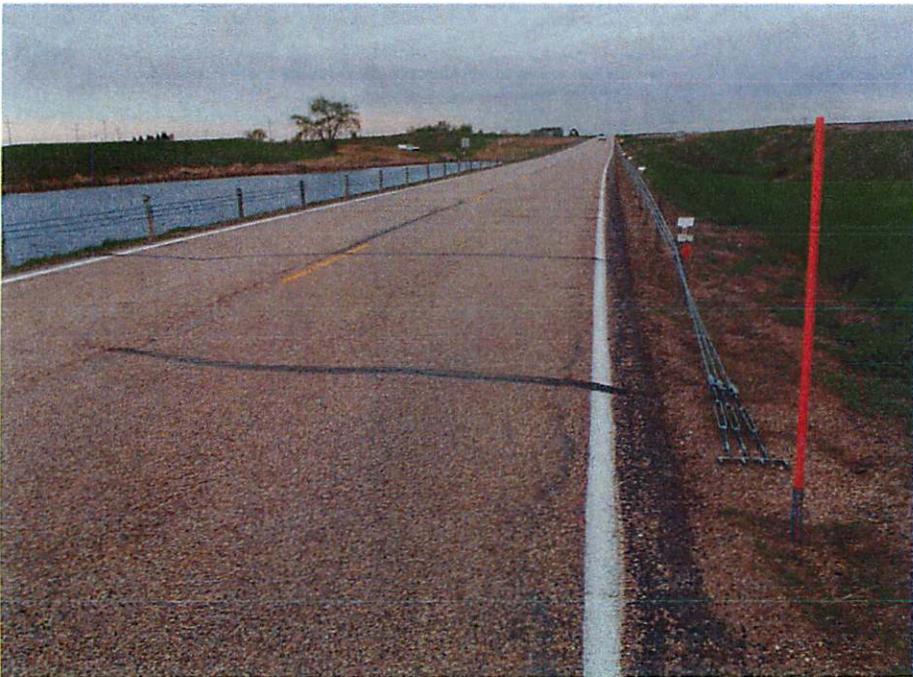
Photo #4 – Crest, looking east.

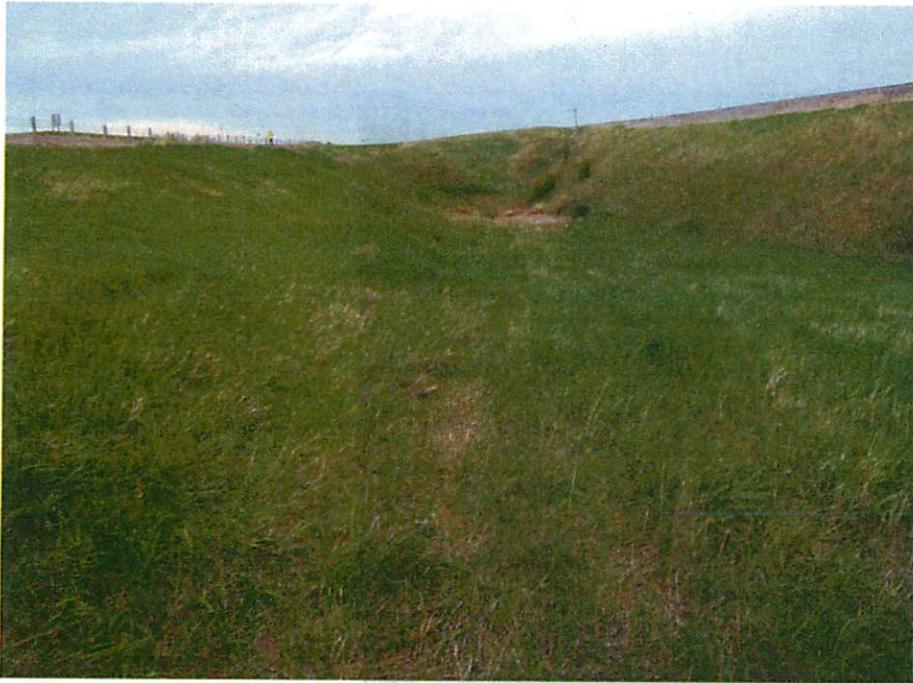
Photo #5 – Downstream slope, looking east.

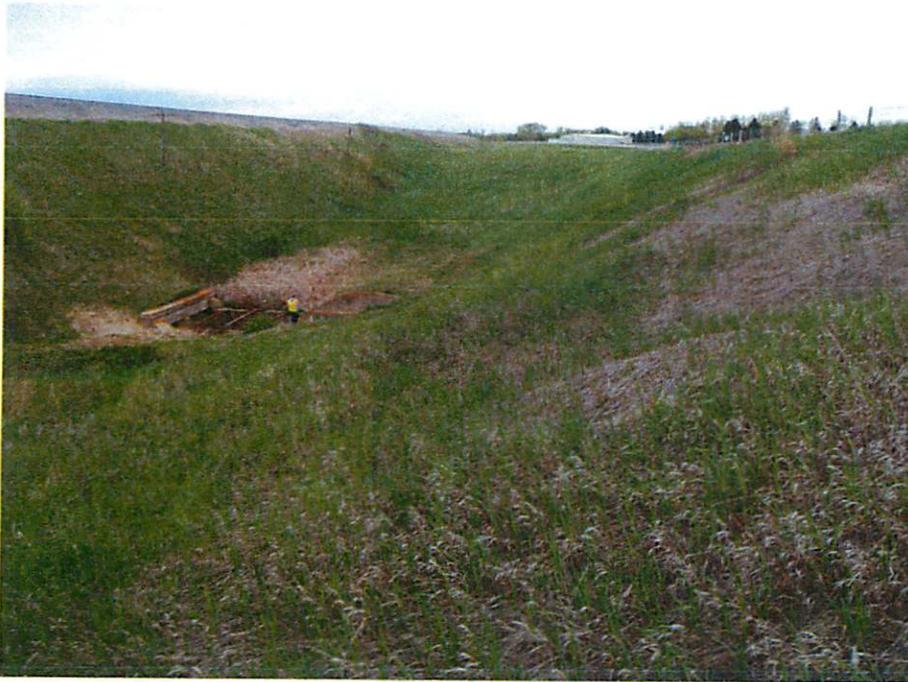
- 2) The dam has a history of concerns regarding uncontrolled seepage through the dam. At the time of this inspection, there was a lot of standing water and cattails at the downstream toe of the dam. Three piezometers installed in the dam in 1991 have been read by the State Water Commission several times each year since their installation. One piezometer is located at the downstream toe of the dam, west of the stilling basin, and it has consistently shown water elevations in the range of 1417-1420 feet. At the time of this inspection, the water elevation in this piezometer was 1419.5 feet. For comparison, the floor of the stilling basin is at elevation 1411, and the lowest sections of the stilling basin walls are at 1417 feet. A geotechnical report completed in 1992 by Twin City Testing concluded that the high water table at the downstream toe is most likely from the reservoir. There is no drainage collection system in the dam.

Photo #6 – Downstream slope, looking west. Note large cattail area at the downstream toe to the west of the stilling basin.

- 1) Replace the existing stilling basin with a new stilling basin. Additional study will be required to evaluate design options for a new stilling basin.
- 2) Install a drainage collection system in the dam, including a drain at the downstream toe of the embankment as recommended in the 1992 geotechnical report Twin City Testing. The installation of a filter diaphragm around the spillway pipe should also be considered. Additional design work will be required for the drainage system.

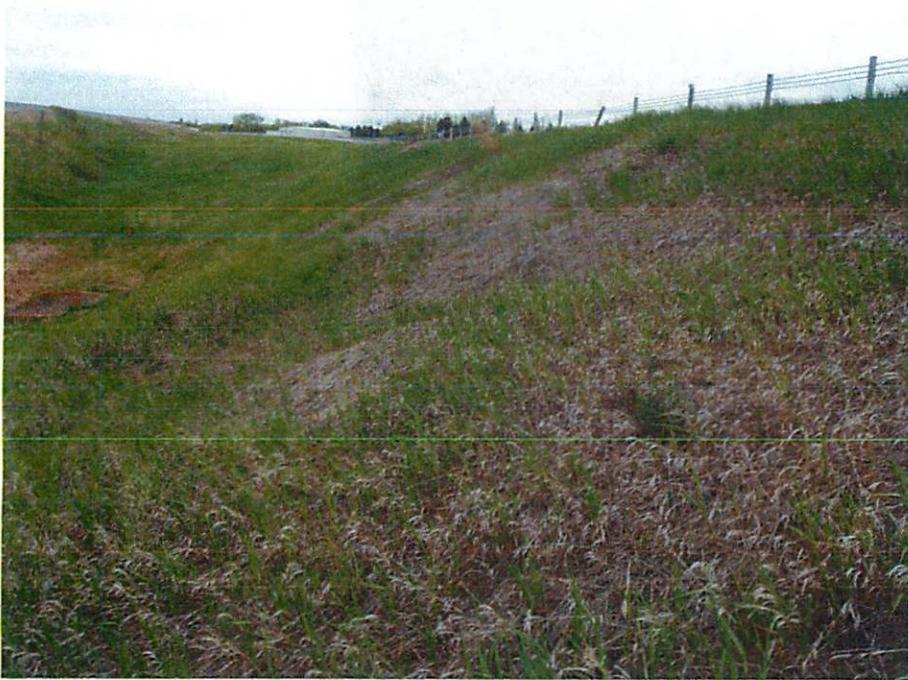
- 4) The upper half of the slope at the east end of the embankment is very uneven with several depressions running vertically up and down the slope, the largest of which is approximately 6 feet wide by 1.5 feet deep, most likely due to erosion of the steep slope. The grass cover in this area is poor.

Photo #7 – Area on upper half of downstream slope at east end of embankment with large depressions, dead grass, bare ground, and many gopher holes.

- 1) Fill the depressions on the upper portion of the downstream slope at the east end of the embankment and re-seed the area with grass.

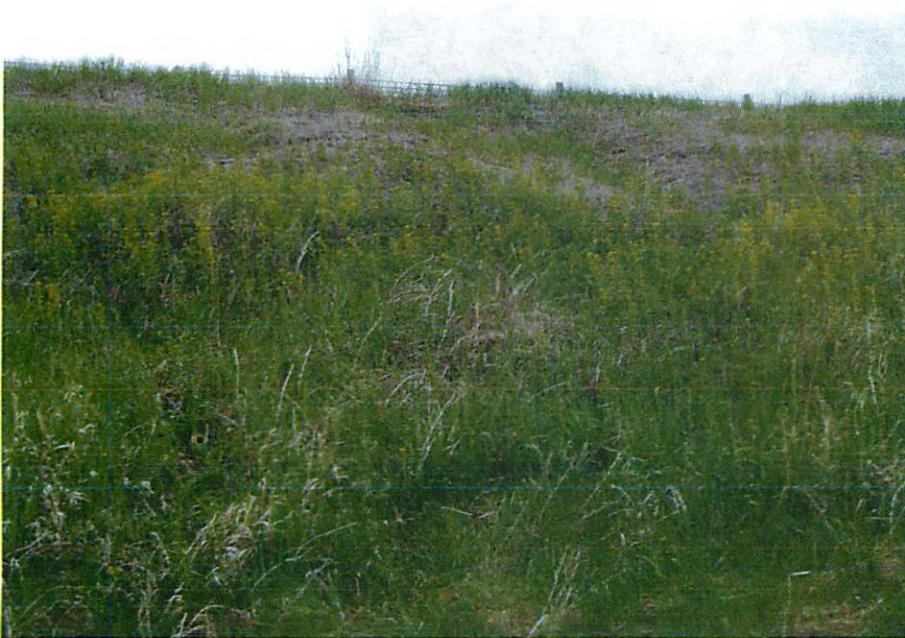
Photo #8 – Depressions on upper half of downstream slope at east end of embankment.

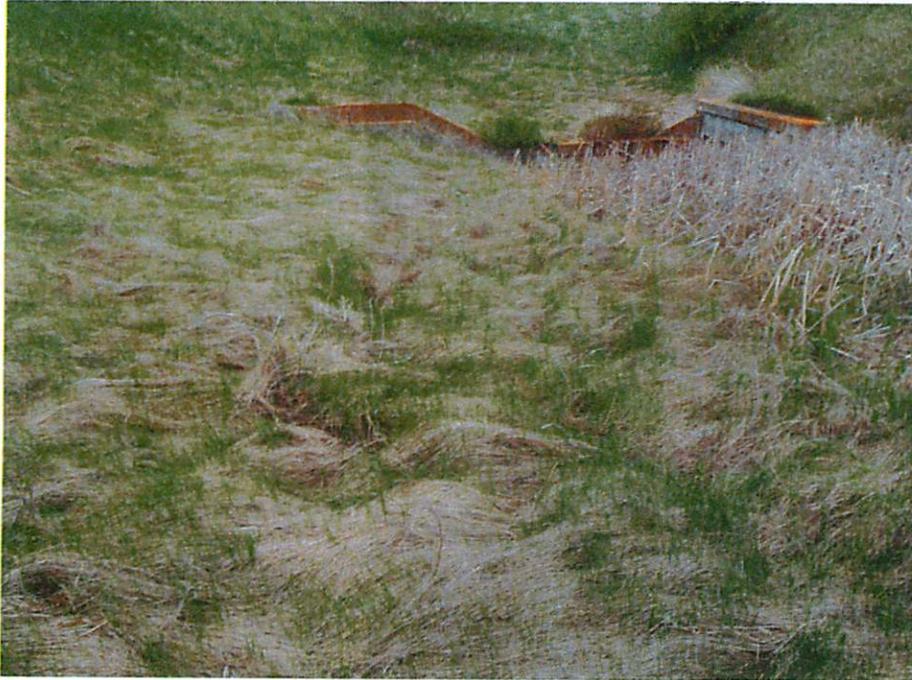
Photo #9 – Area at downstream toe west of stilling basin with cattails, standing water, and rough uneven ground.

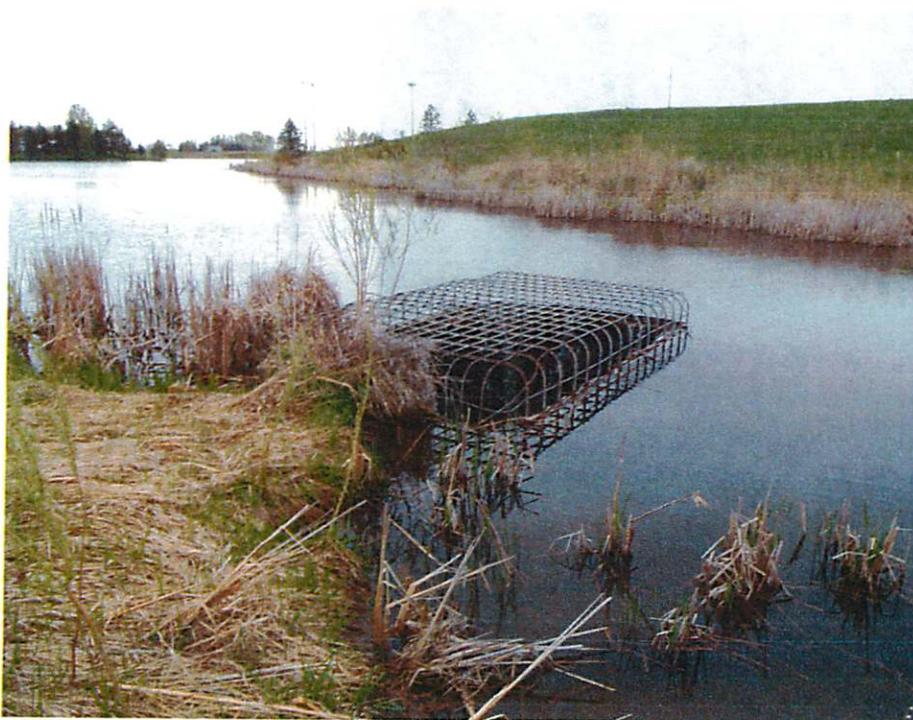
Photo #10 – Principal spillway inlet.

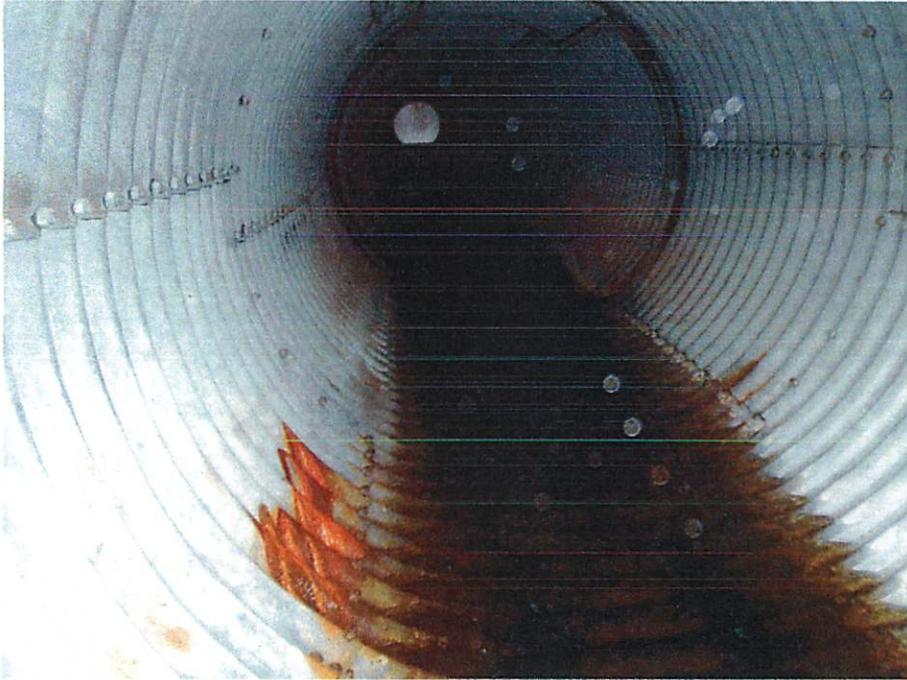
- 3) The 8-foot diameter pipe under the highway functions as the dam's only spillway. The interior of this pipe was inspected, and no major problems were observed at present. There is seepage around many of the bolts in the pipe and there are also a few pinhole leaks in the pipe. The pipe has a history of seepage and past investigations have found saturated soil conditions around the pipe. Given these conditions, the outside of the pipe that cannot be seen may be in worse condition than the inside of the pipe. The design life for metal conduits in dams is typically around 50 years, so this pipe is at the end of its design life.

Photo #11 – Interior of principal spillway conduit.

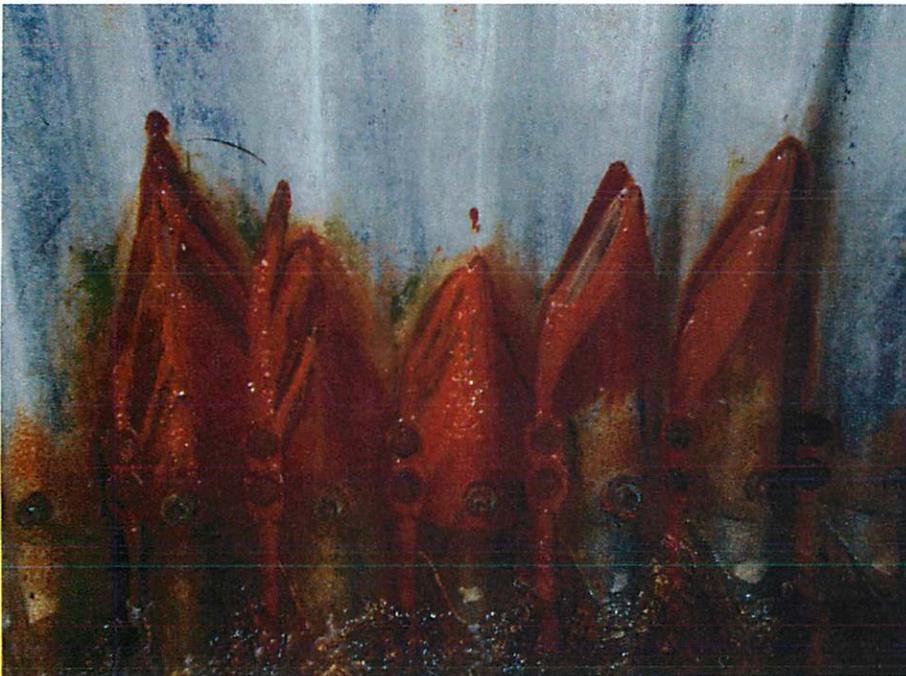
Photo #12 – Small pinholes with seepage in principal spillway conduit.

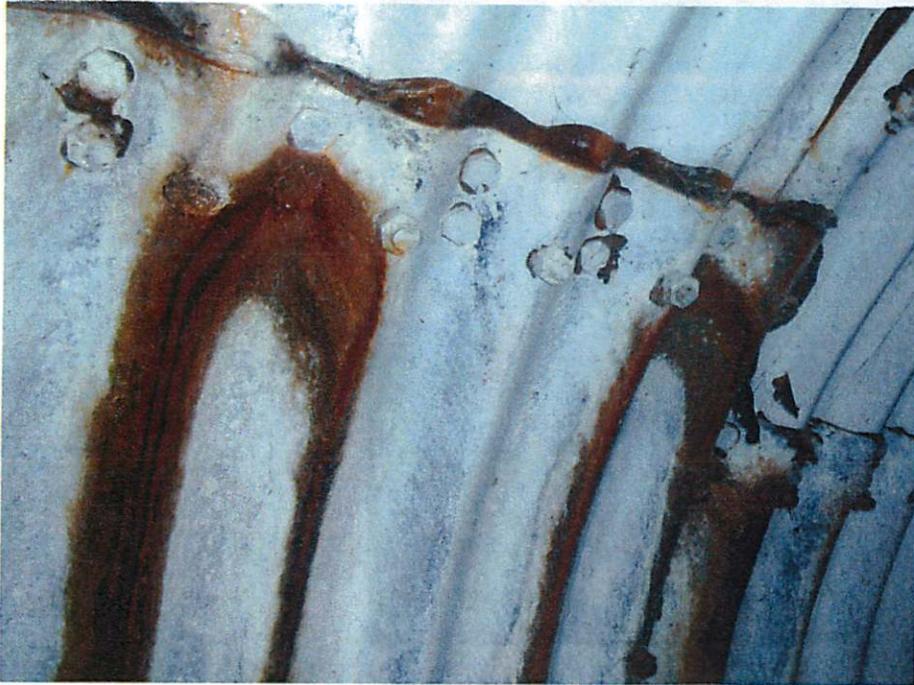
Photo #13 – Seepage at bolts inside principal spillway conduit, typical.

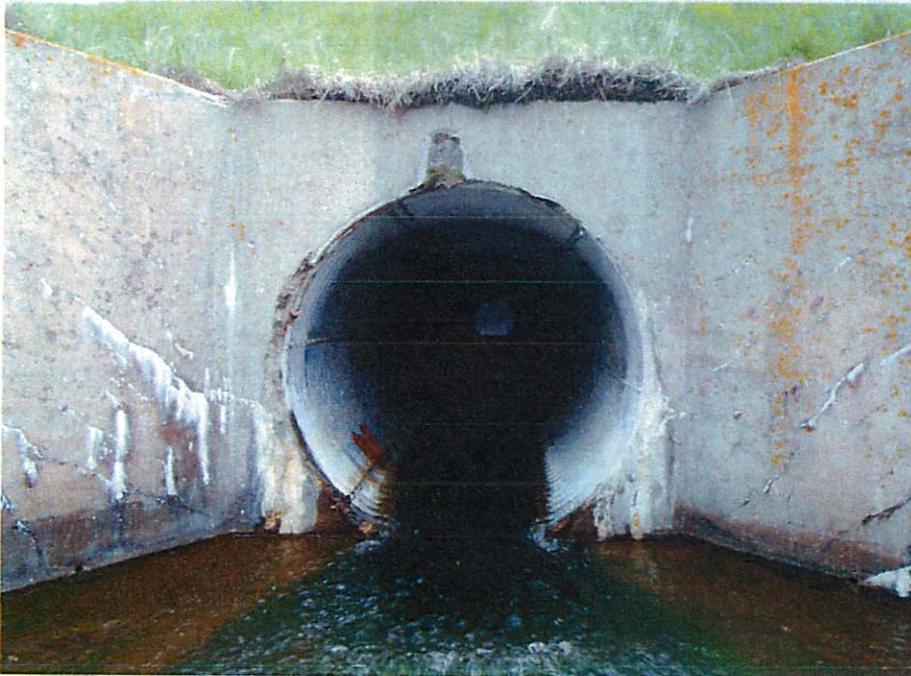
Photo #14 – Principal spillway outlet.

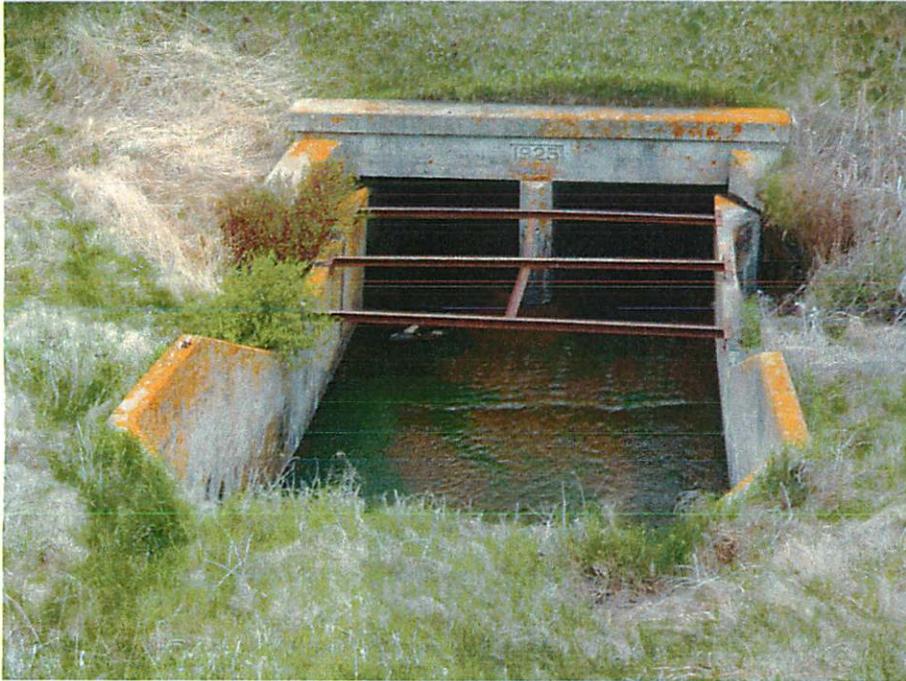
- 1) The stilling basin is in very poor condition.
  - Both the east and west walls of the stilling basin are failing structurally and are deflecting inward. Braces were placed across the stilling basin to support the walls in 1990, but two of the three braces are no longer functioning at all because the concrete has deteriorated so much that the braces no longer have any support. Both concrete walls have extensive cracking and deterioration.

Photo #15 – Principal spillway stilling basin, looking downstream.

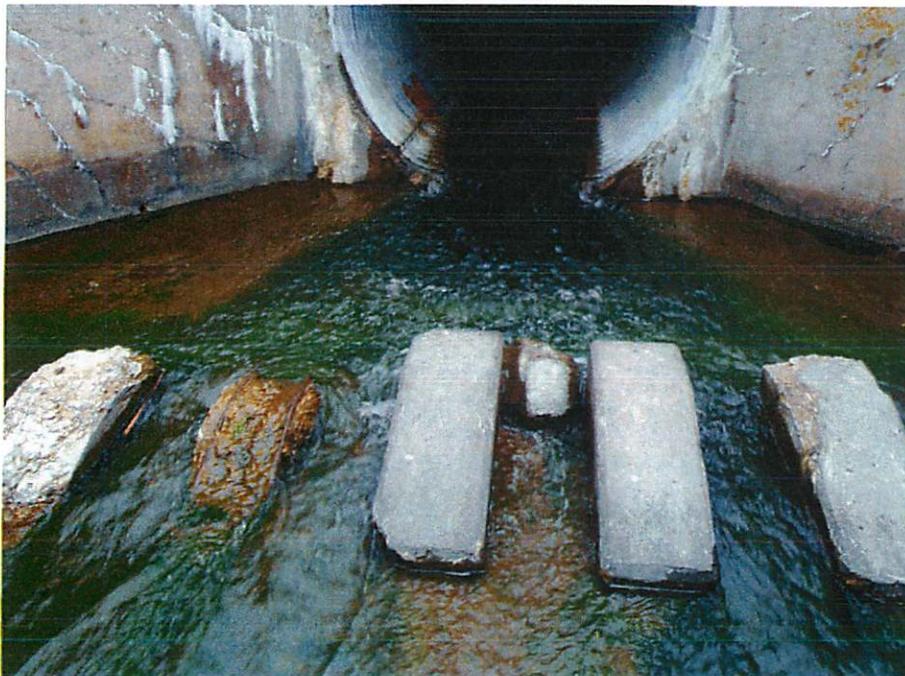
- There are five concrete baffle blocks on the floor of the stilling basin. Two of these baffle blocks are badly deteriorated and another one is damaged. These baffle blocks are important for energy dissipation in the stilling basin and the damage to these baffle blocks will further decrease the ability of the stilling basin to function properly.

Photo #16 – Baffle blocks in the stilling basin. The two on the west side are badly deteriorated and the one on the east side is damaged.

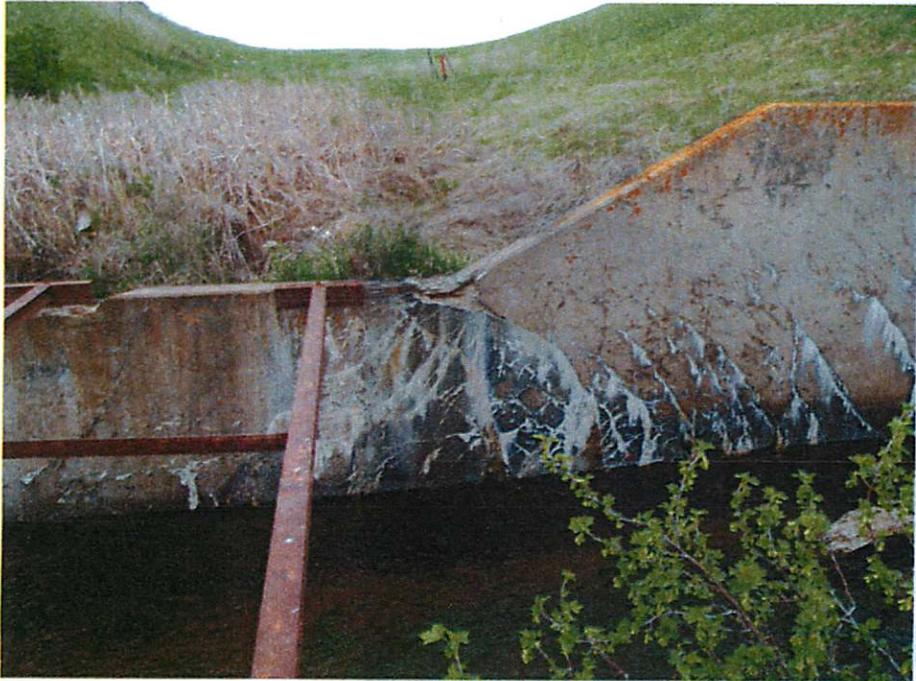
Photo #17 – Cracking and deterioration of the west stilling basin wall. Also note the cattail area west of the stilling basin.

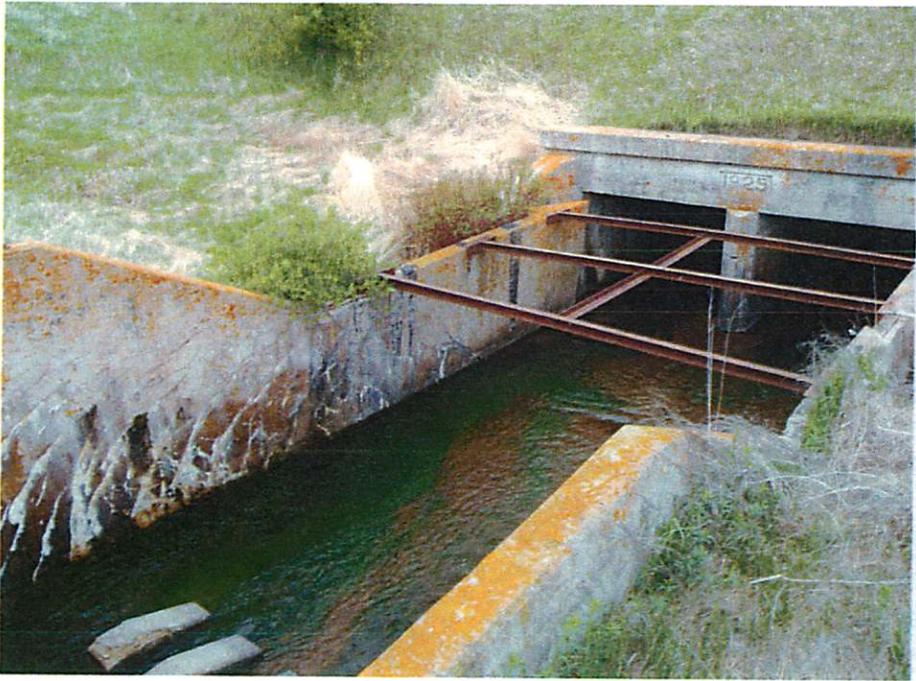
Photo #18 – Cracking and deterioration of the east stilling basin wall.

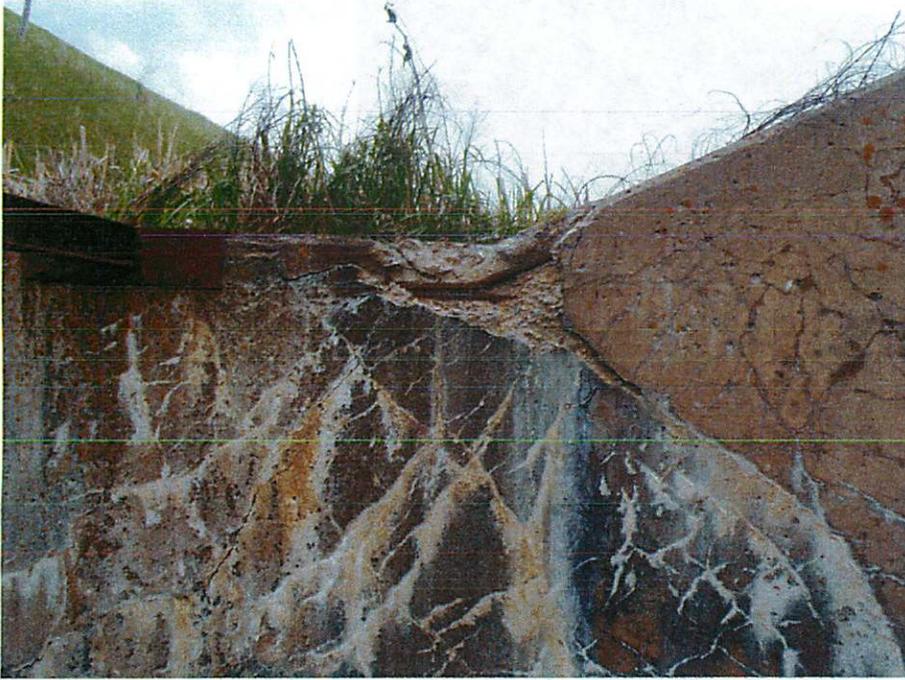
Photo #19 – Deterioration at the top of the west stilling basin wall.

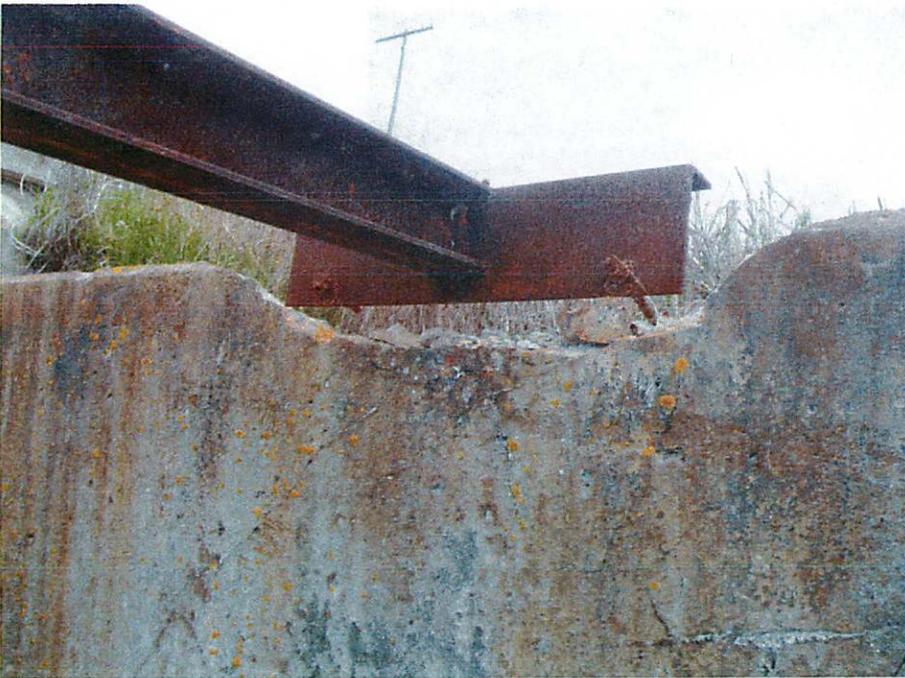
Photo #20 – Deterioration at the top of the west stilling basin wall. The middle cross brace is no longer supported on the west side.

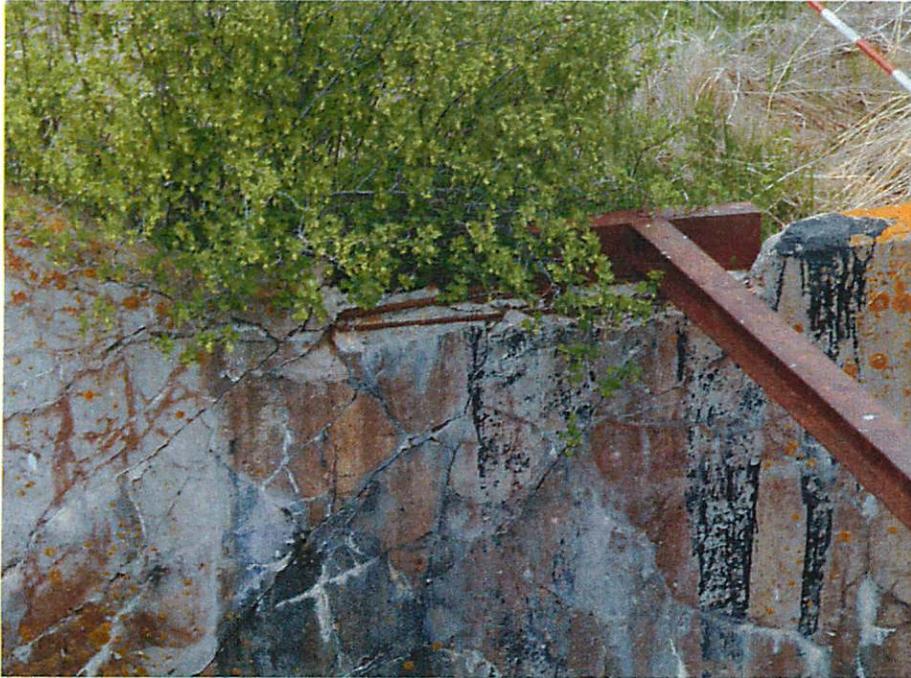
Photo #21 – Deterioration at the top of the east stilling basin wall. The most upstream cross brace is no longer supported on the east side.

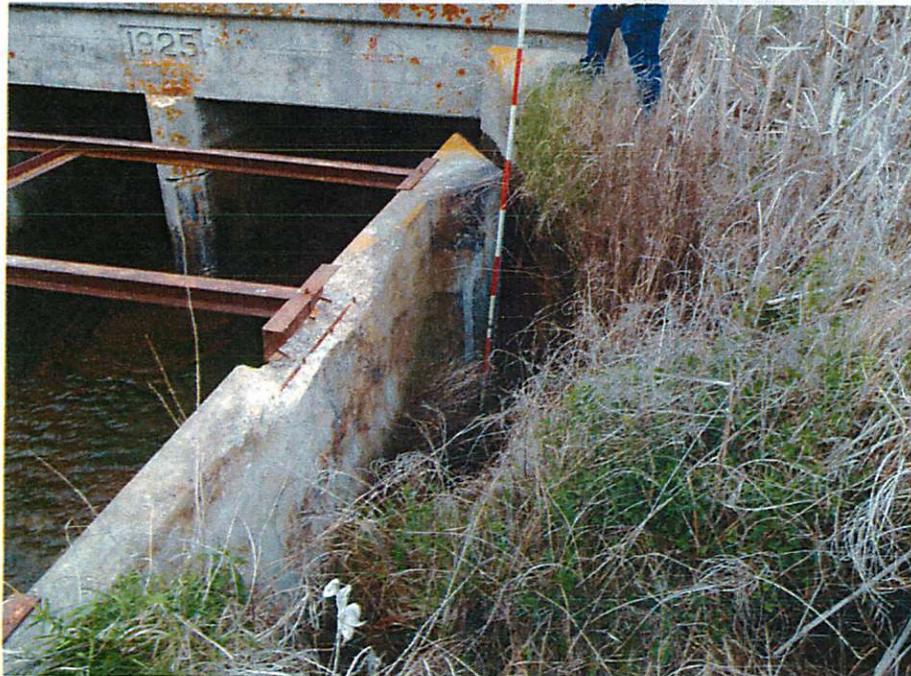
- There are large eroded areas behind both stilling basin walls. Because the walls are leaning inward, there is a large gap between each stilling basin wall and the headwall of the railroad culvert. These gaps allow water flowing through the dam's spillway to circulate behind the stilling basin walls and cause the erosion. Surface runoff and seepage around the stilling basin are also likely contributors to the erosion, carrying soil through the gaps in the walls.

Photo #22 – Erosion behind the west stilling basin wall.

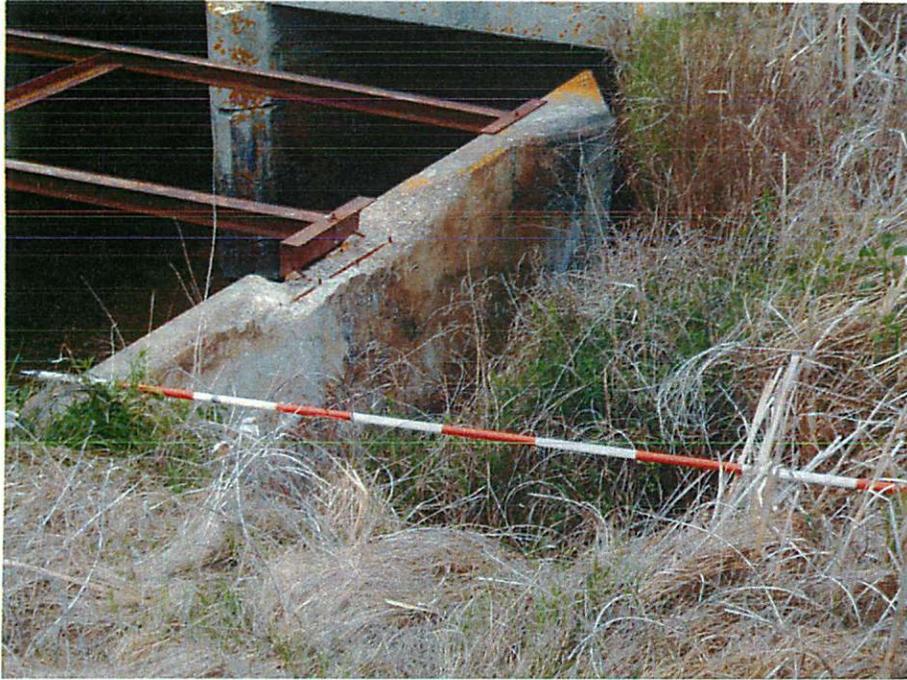
Photo #23 – Erosion behind the west stilling basin wall.

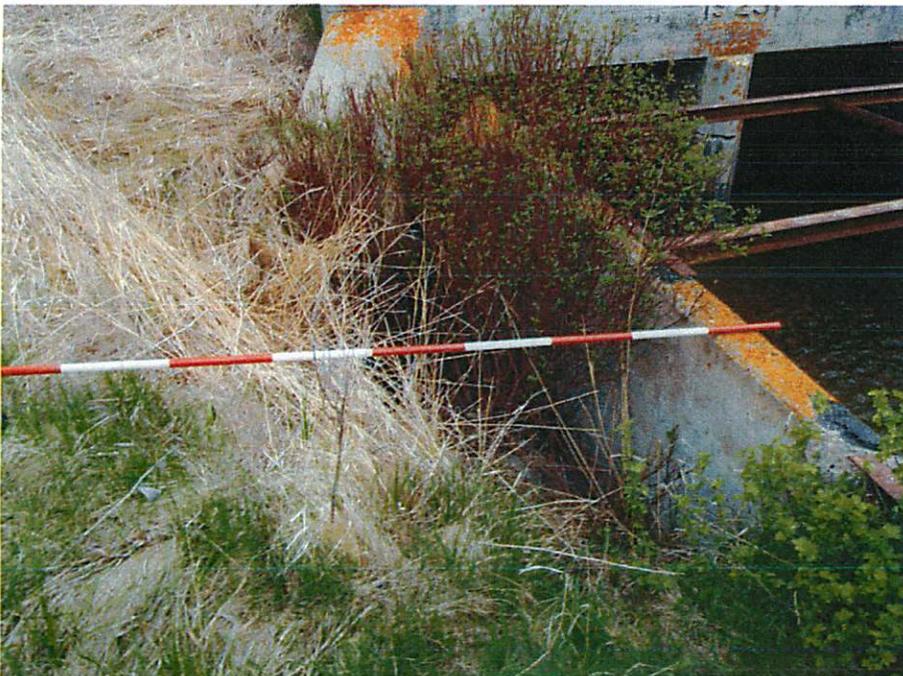
Photo #24 – Erosion behind the east stilling basin wall.

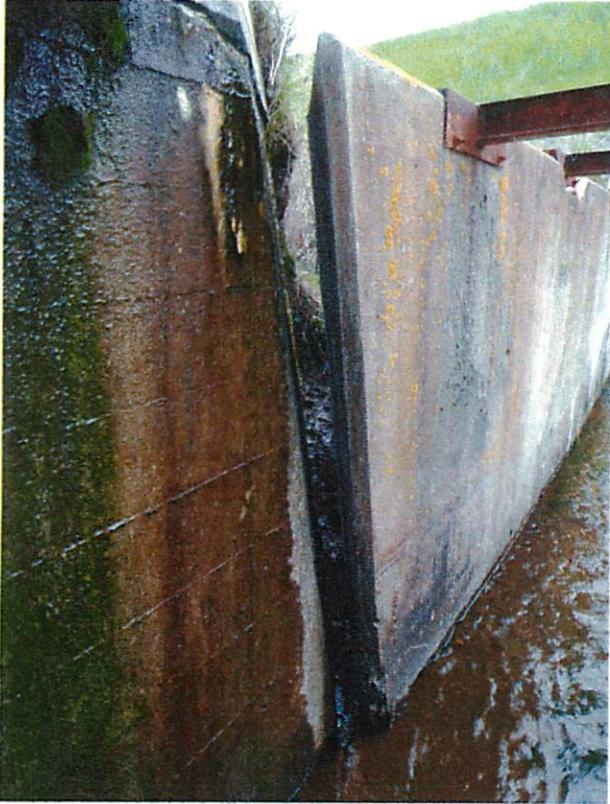
Photo #25 – Deflection of the west stilling basin wall.

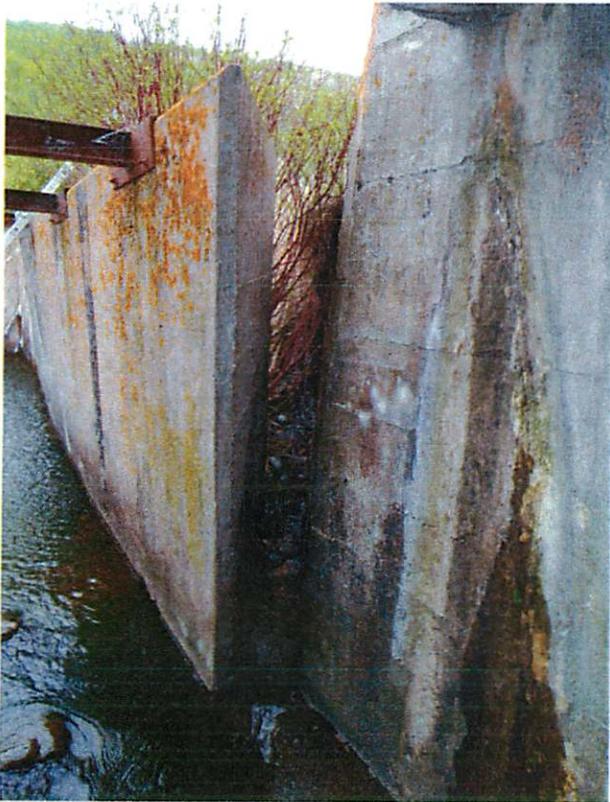
Photo #26 – Deflection of the east stilling basin wall.
